Manhole Inspection Summary

Manhole # S17Y__001MH

Insp Date: **6/24/08 9:28 AM**

Location Address: **1503 wilmington av**

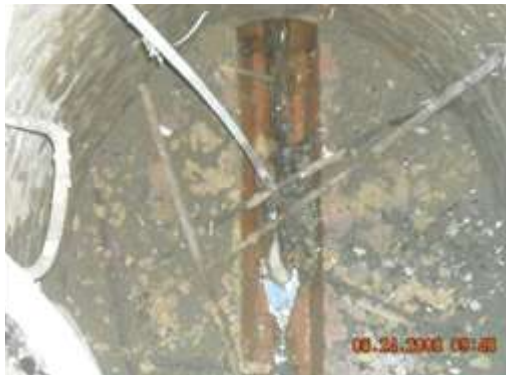
Misc

debris in channel

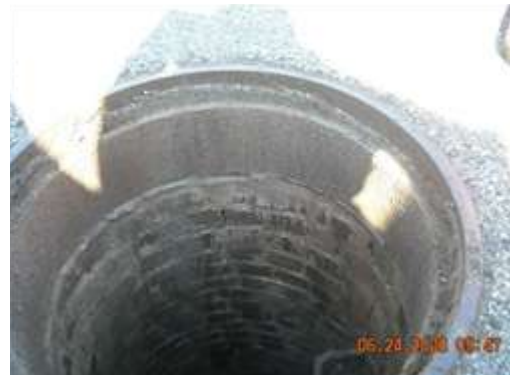
Misc

Subject To Ponding: **Sheeting**

inflow evidence from sheeting

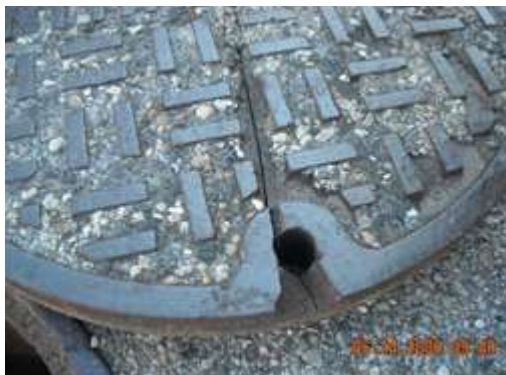
Defect 1

Condition: **Cracked**

cracked cover

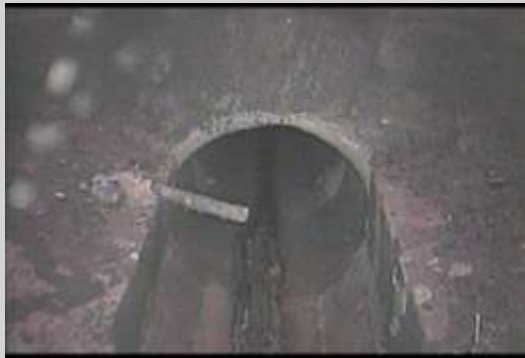
12 O'Clock Outflow

8 in. Circular Gravity Sewer
Pipe Out @ 12 O'Clock

Pipe Height: **8.4** (in.) Rod and Bar (Angled)
Pipe Material: **Clay** ☐ Pipe Lined
Invert Depth: **9.32** (ft.) Flow Characteristics: **Slow**
Deposits: ☒ None ☐ Mud ☐ Sludge ☐ Debris ☐ Grease
Silt Depth: **0** (in.) Deposits Extent:
Infiltration: **None** Pipe Seal Cond: **Sound**

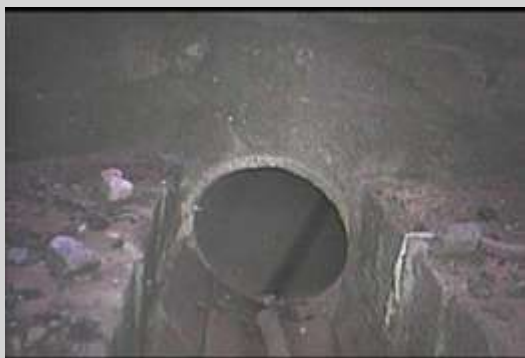
6 O'Clock Inflow

6 in. Circular Gravity Sewer
Pipe In @ 6 O'Clock

Pipe Height: **6** (in.) Rod and Bar (Angled)
Pipe Material: **Clay** ☐ Pipe Lined
Invert Depth: **9.10** (ft.) Flow Characteristics: **Slow**
Deposits: ☒ None ☐ Mud ☐ Sludge ☐ Debris ☐ Grease
Silt Depth: **0** (in.) Deposits Extent:
Infiltration: **None** Pipe Seal Cond: **Sound**
